NASA CR-120888
Contract NAS3-12023

Final
Report

Composite Overwrapped Metallic Tanks

MARTIN MARIETTA CORPORATION

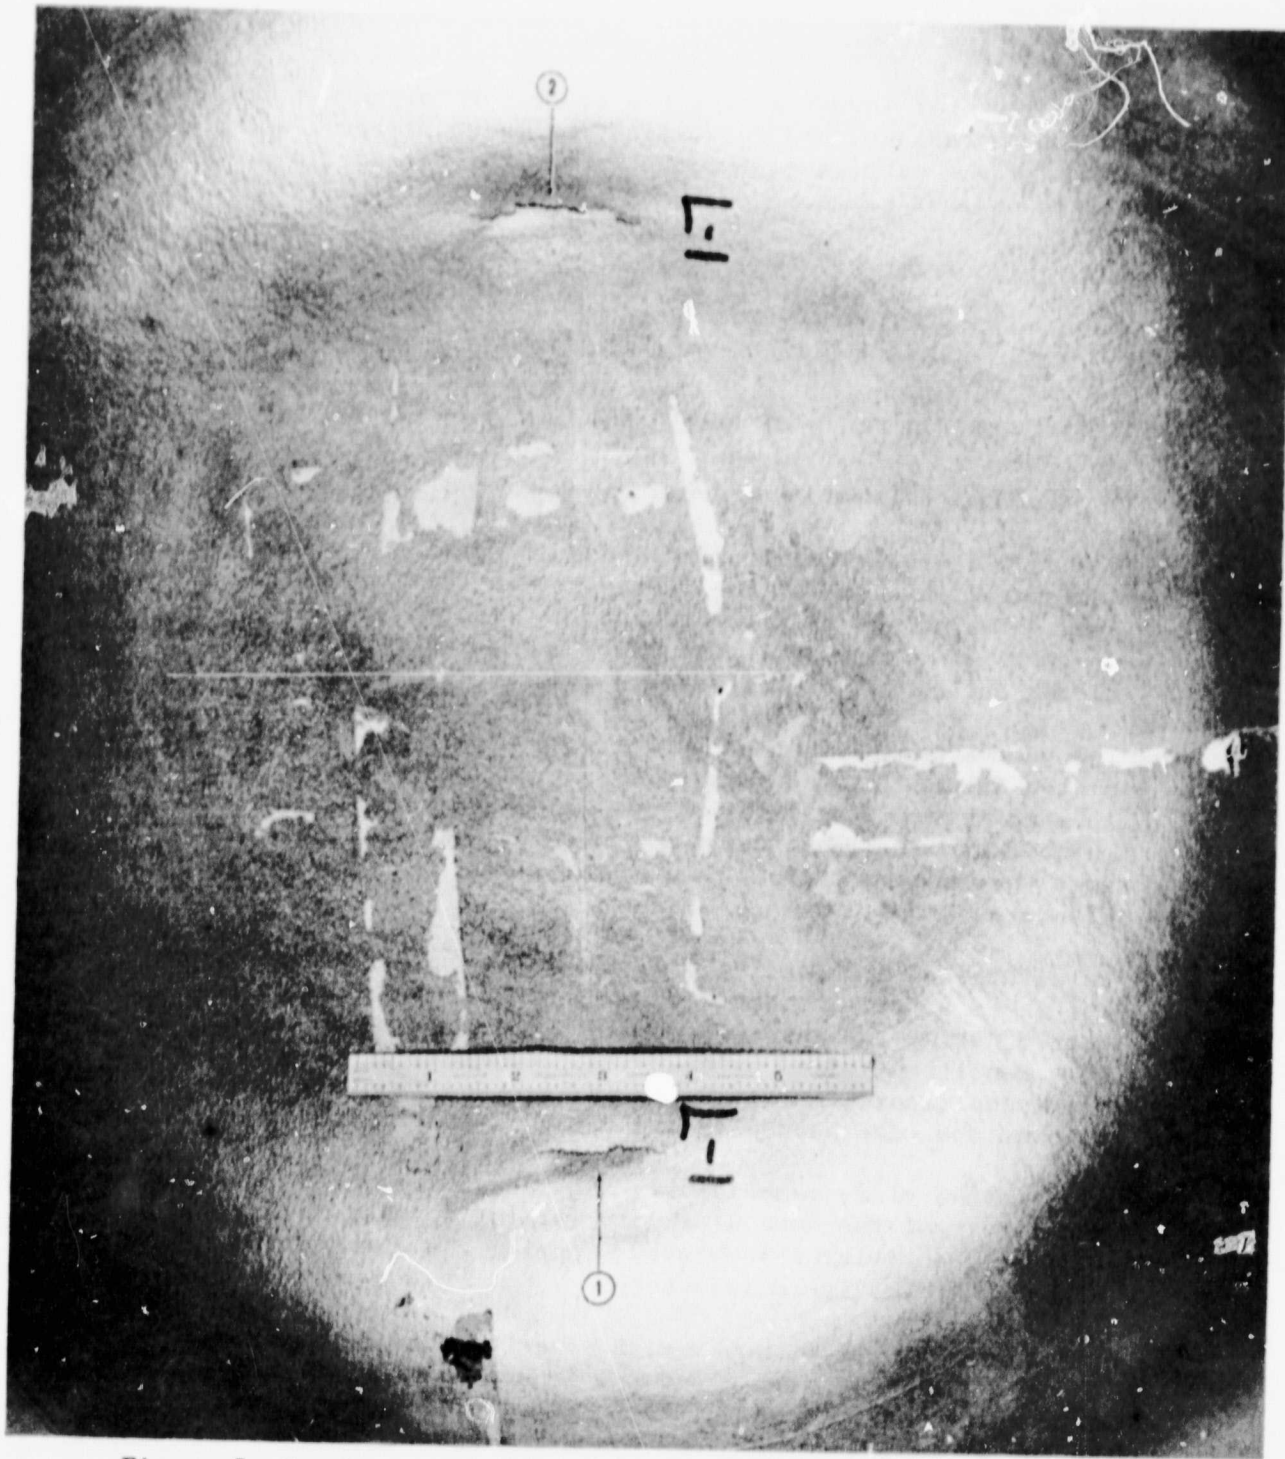
Figure 5 Cracks on the Inside Surface Near the Apex of Dome L1
